**Flood Control Project Maintenance
Levee Inspections****LMA District Cover Sheet****Spring 2013 Levee Inspection Results****Reclamation District No. 1601 Twitchell**

Levee Inspection Report By Mile - Spring 2013

Reclamation District No. 1601 Twitchell

Waterway					Bank	Unit Miles	Inspection Start/End	Inspector	
Unit No. 01 Threemile Slough					Left	2.47	03/14/2013 03/14/2013	Richard Willoughby

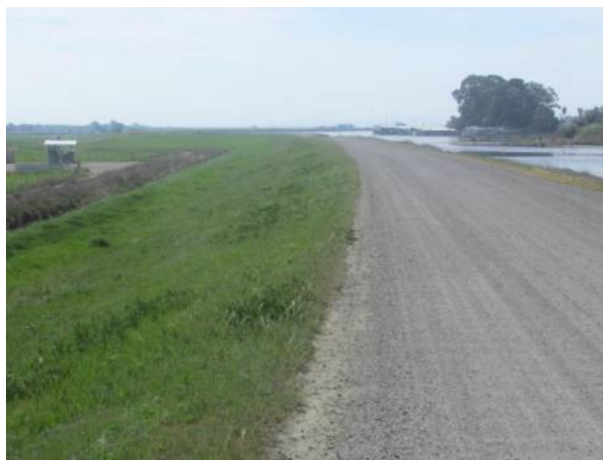
Levee Mile Report Line	4
Start Levee Mile	0.00
End Levee Mile	2.47
Location	Land Side
Category	
Item	Vegetation

Looking southeast at typical view of levee.

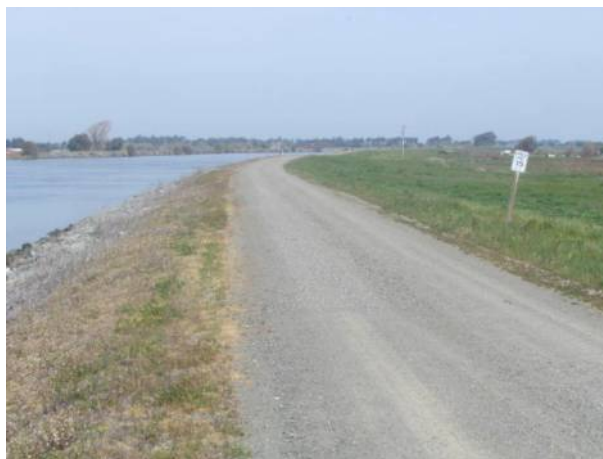
Levee Mile Report Line	5
Start Levee Mile	0.00
End Levee Mile	2.47
Location	Water Side
Category	
Item	Vegetation

Looking northwest at typical view of levee.

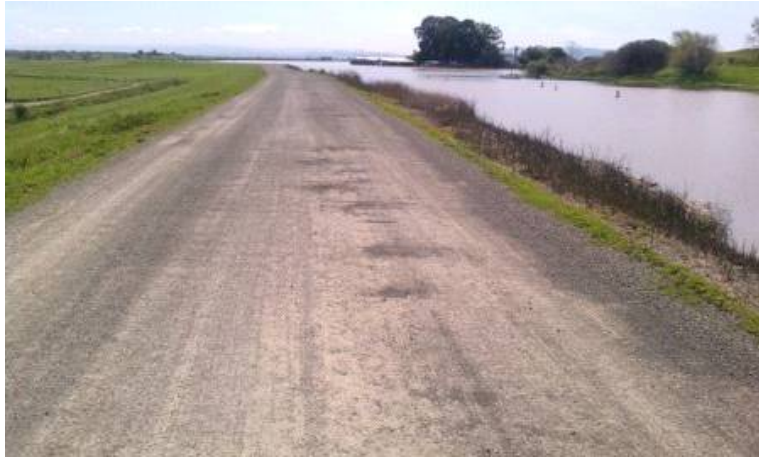
Levee Mile Report Line	6
Start Levee Mile	0.10
End Levee Mile	2.47
Location	Crown
Category	
Item	Crown Surface / Depressions / Rutting
Looking south at crown surface rutting.	
richard_s_20130304_935.jpg

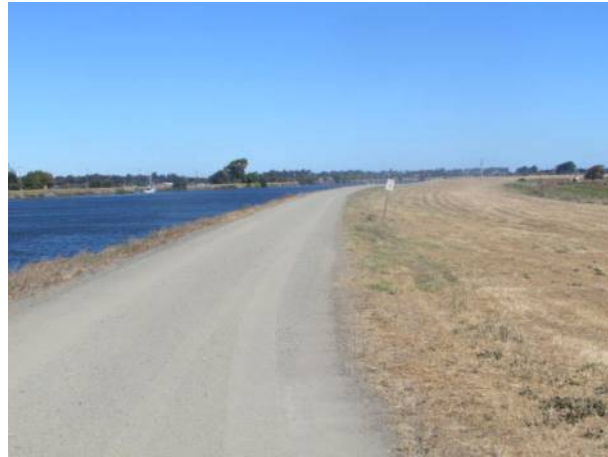
Levee Mile Report Line	6
Start Levee Mile	0.10
End Levee Mile	2.47
Location	Crown
Category	
Item	Crown Surface / Depressions / Rutting
Looking southwest at re-grade crown roadway.	
richard_s_20130304_936.JPG

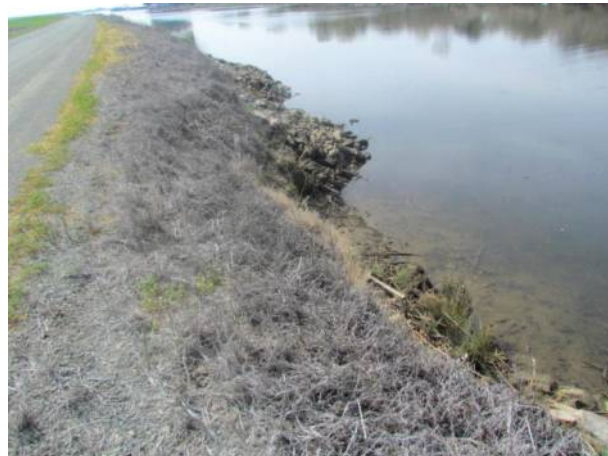
DWR ID: DWR_RD1601_01_s_2012_5										
7	0.17	0.17		Erosion / Bank Caving	CR	M Ma	E1 : Note and monitor erosion site.	38.119832 ° -121.682762 °	38.119832 ° -121.682762 °	4 Y
DWR ID: DWR_RD1601_01_s_2013_4										
8	0.18	0.18		Erosion / Bank Caving	CR	M Ma	E1 : Note and monitor erosion site.	38.119698 ° -121.682760 °	38.119698 ° -121.682760 °	3 Y
DWR ID: DWR_RD1601_01_s_2013_3

Levee Mile Report Line	7
Start Levee Mile	0.17
End Levee Mile	0.17
Location	Crown
Category	
Item	Erosion / Bank Caving
Looking south at erosion on waterside toe.	
richard_s_20130315_991.JPG

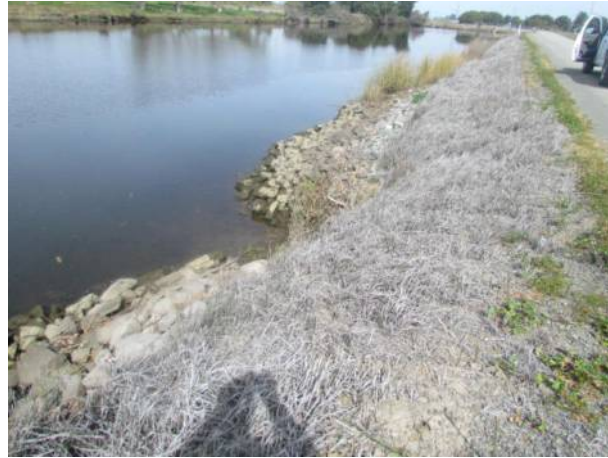
Levee Mile Report Line	8
Start Levee Mile	0.18
End Levee Mile	0.18
Location	Crown
Category	
Item	Erosion / Bank Caving
Looking northwest at eroision on waterside toe.	
richard_s_20130315_992.JPG
